West Elgin Distribution System
Operations Report
Third Quarter 2020

Submitted by:
Ontario Clean Water Agency
Date: November 5, 2020

Facility Name: West Elgin Distribution System

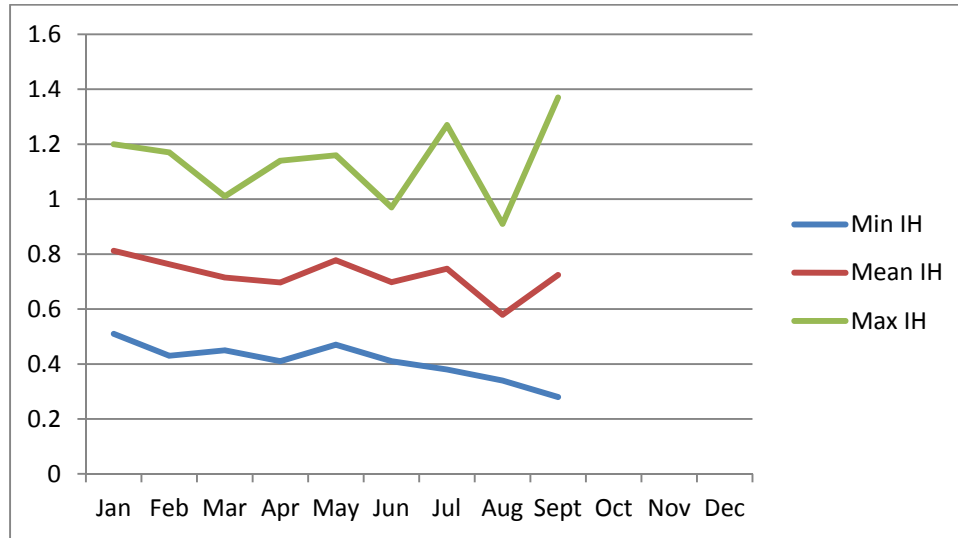
The Rodney Tower continuously monitors the free chlorine residual of the water. The results fluctuate based on fill cycles. During the winter months the results are usually very good, however, once there is warmer weather the chlorine residuals dissipate. In spring of 2018 the Rodney tower installed a re-chlorination facility. Chlorine residuals are taken throughout the distribution system in accordance to O. Reg. 170/03 requirements. The graph below provides the minimum, maximum and average chlorine residuals throughout the distribution system in 2019.
